Kirby-le-Soken Conservation Area Character Appraisal and Management Plan

Tendring
District Council

Date:
September 2022

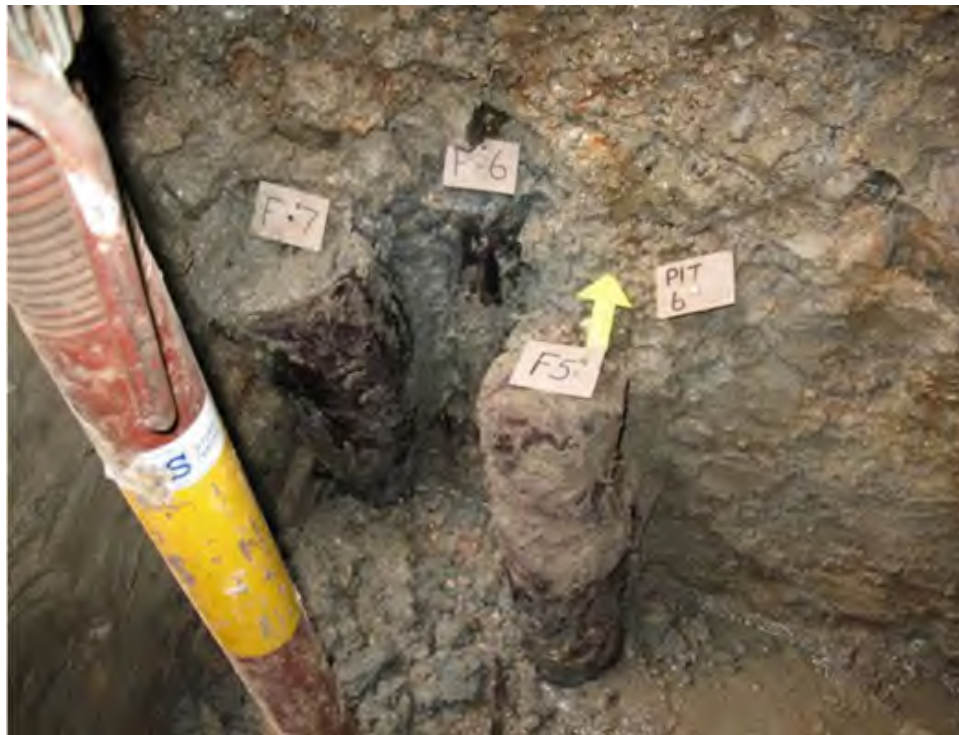
Figure 3 Three wooden piles beneath church tower.

The village church is fourteenth century in origin but has been the subject of significant alterations and is now largely a nineteenth century building. Archaeological monitoring during repairs to the church exposed three water-logged wooden piles beneath the tower, that were dated as having been felled between 1330 and 1400 (Figure 3).

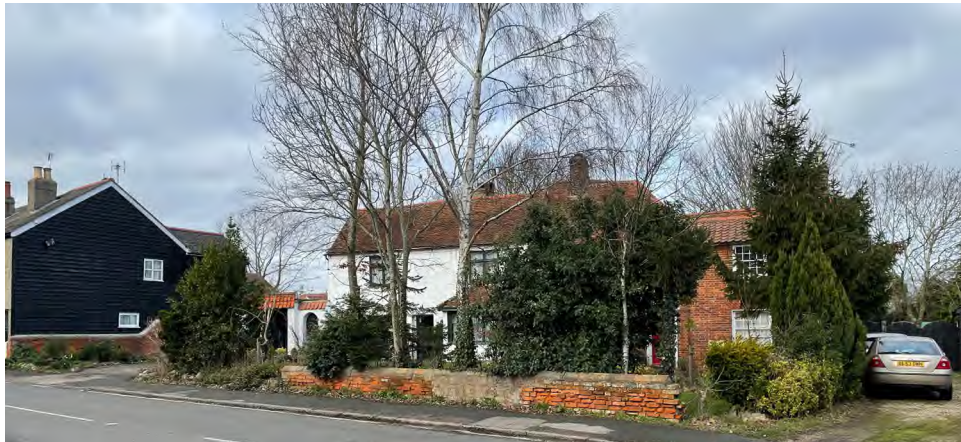
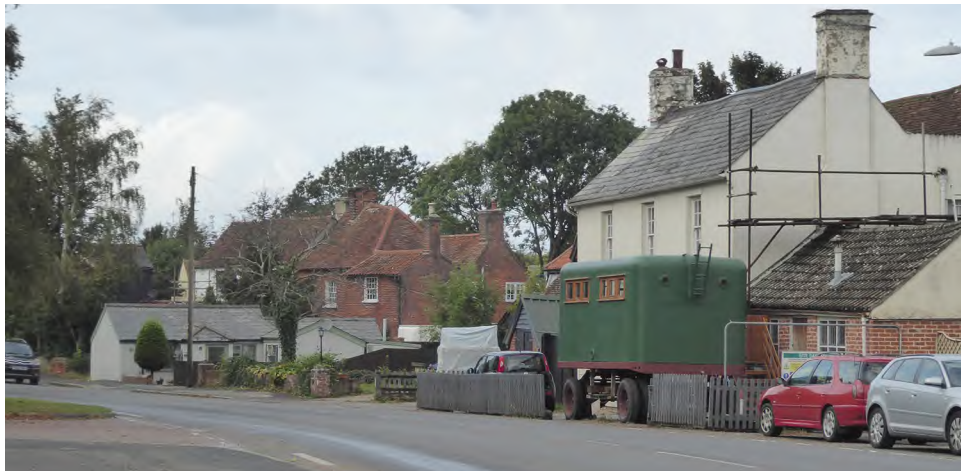
Figure 16 Photograph of Grade II listed Red House White House

Figure 17 Photograph looking west showing the roofscape of Red House White House in the background with Waterloo House in the foreground

Numbers 46-50 are a row of roughcast rendered terraced properties fronting the pavement, beyond this terrace is Red House White House, which is well set back from the road, enabling a break up in the density of built form (Figure 16). From Red House White House to Number 34, the dwellings are evenly spaced with larger front gardens bound by low red brick walls; the size of their front gardens is unique to this row. Numbers 36 and 38 do not form part of the area's historic development, however their scale and appearance are sympathetic to the setting of Red House White House and the character of the Conservation Area. The setback arrangement of this part affords views looking west of the attractive and complex roofscape of Red House White House.

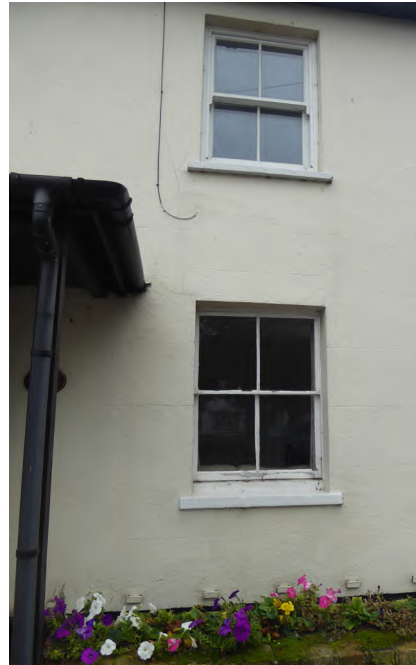
Figure 32 Traditional windows of Number 28 The Street

The architectural detailing in this character area is simple which is indicative of the rural village character. Properties are either gabled or hipped in form. There are some properties that retain traditional timber windows which is positive; however, many have been replaced with modern uPVC and aluminium of untraditional colours which detract.

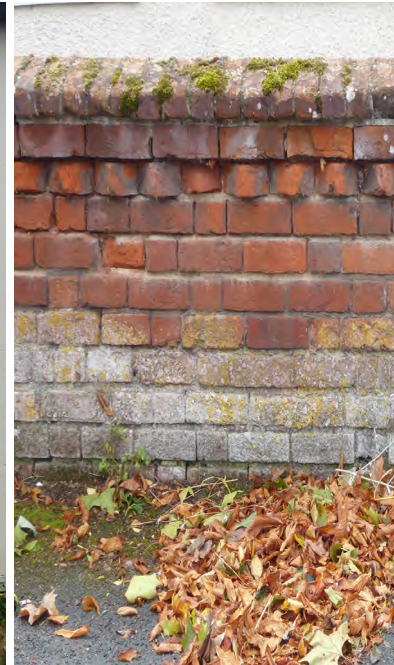
Figure 33 Traditional low brick wall surrounding the church hall

Boundary treatments within the western end of the Conservation Area where the road is narrow are predominantly hedges which softens the approach into the Conservation Area. Some of the hedges are substantial and frame the entrance into the Conservation Area. Soft boundary treatments are less prevalent progressing into the centre of the Conservation Area from and to the east end. There are some characterful picket fences as well as low redbrick walls which contribute to the traditional appearance of the Conservation Area.

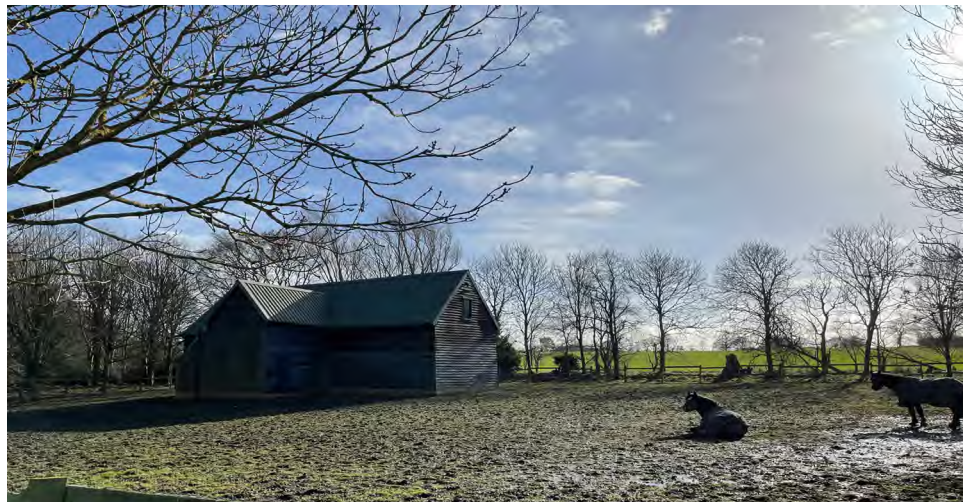
Figure 37 Barn southwest of Kirby Hall

The materials of the residential buildings are traditional and well preserved due to their statutory listing. Red brick, render, red clay and slate roof tiles are used within this character area. The barn is black weatherboarded which sits on a red brick plinth. However, the traditional roof covering has been replaced with a corrugated asbestos roof which is unsympathetic.

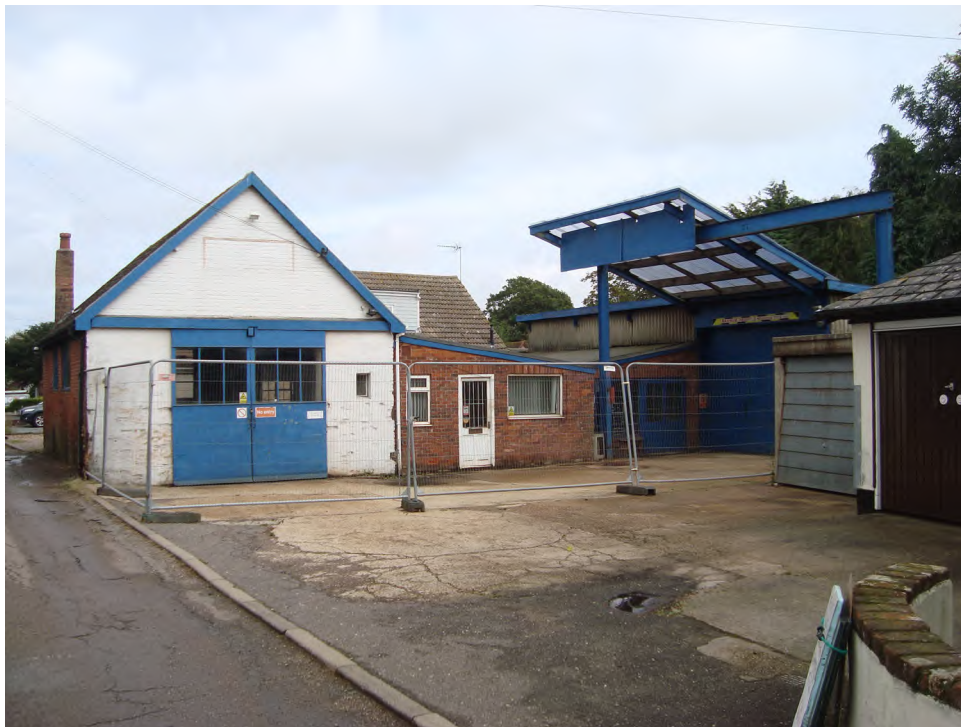
Figure 52 Former site of Oxborrow Engineering

Within the centre of the Conservation Area there are views from The Street of a service yard and building (formerly Oxborrow Engineering) which sits behind Number 28 on Maltings Lane (Figure 52). The single storey red brick building with white painting facade is a characterful industrial structure with a chimney to the rear and contributes to a variation in the predominantly residential streetscene. It is recommended to include this property within the Conservation Area.
